Assessment of Dam Safety

Coal Combustion Surface Impoundments (Task 3)

American Electric Power

Conesville
Generating Station

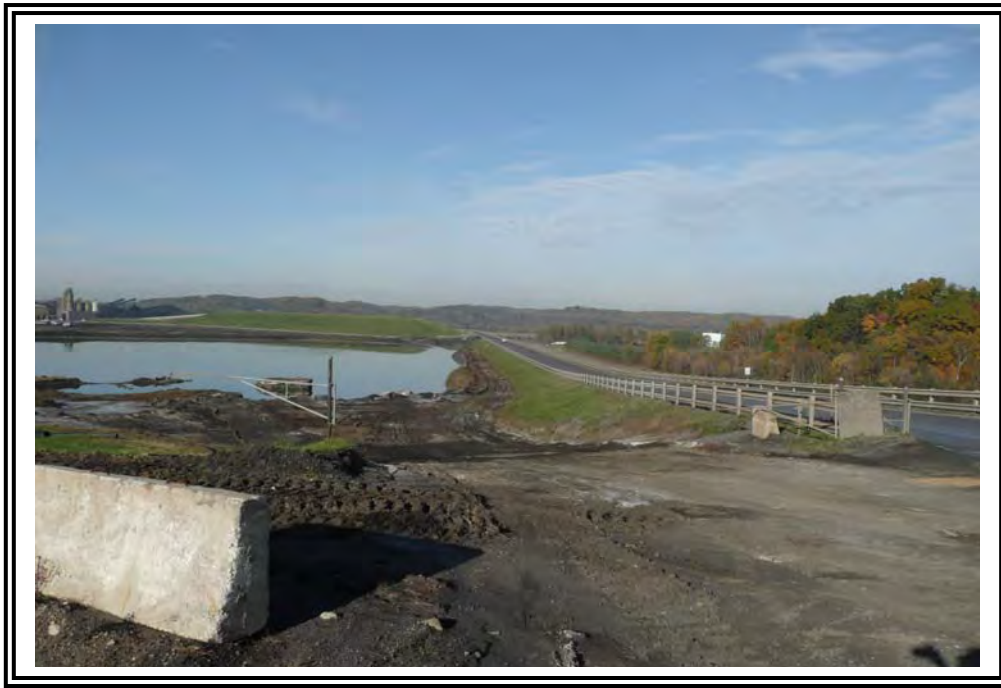
1

Looking west across the north corner of the Fly Ash Pond along upstream slope of North Haul Road Dike.
The plant and closed FGD area are in the background.

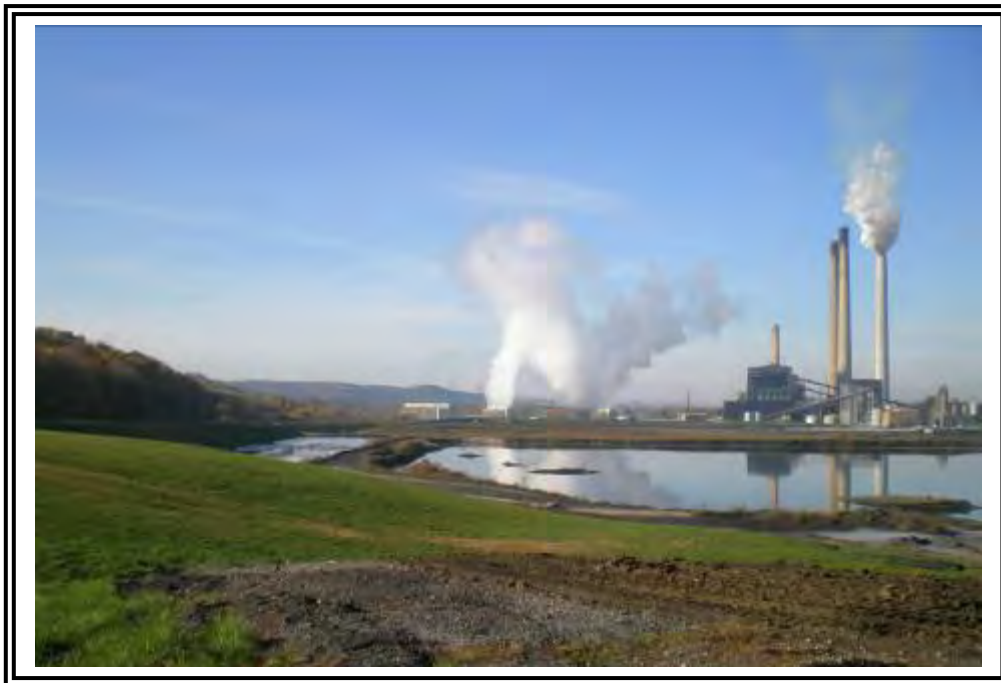
2

Looking southwest across the Ash Pond Complex.

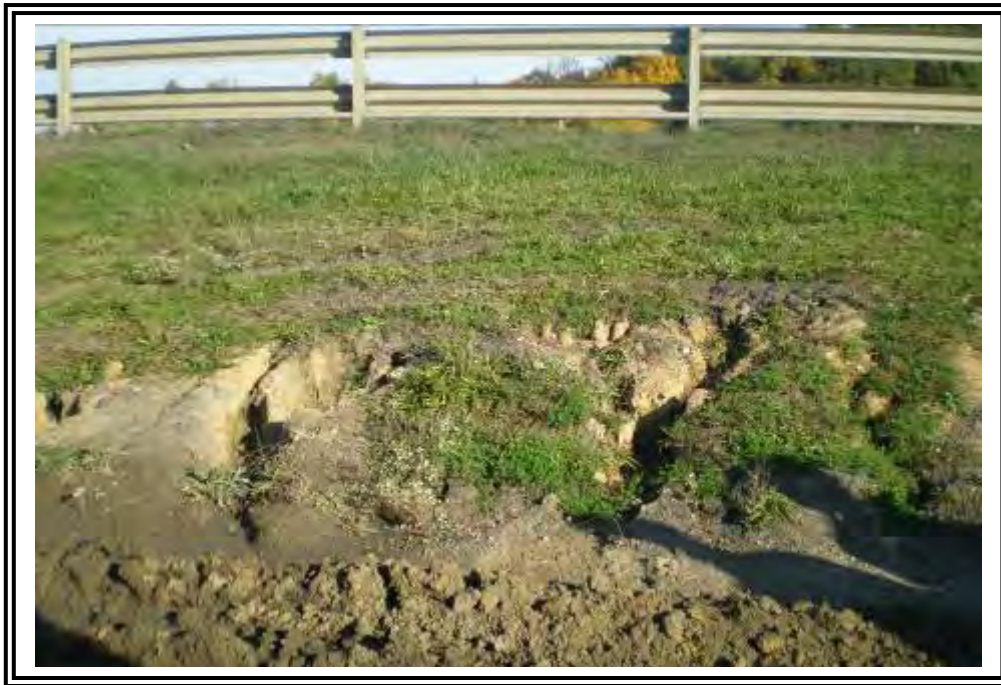
3

Erosion rills from haul road run off on the upstream slope of the North Haul Road Dike.

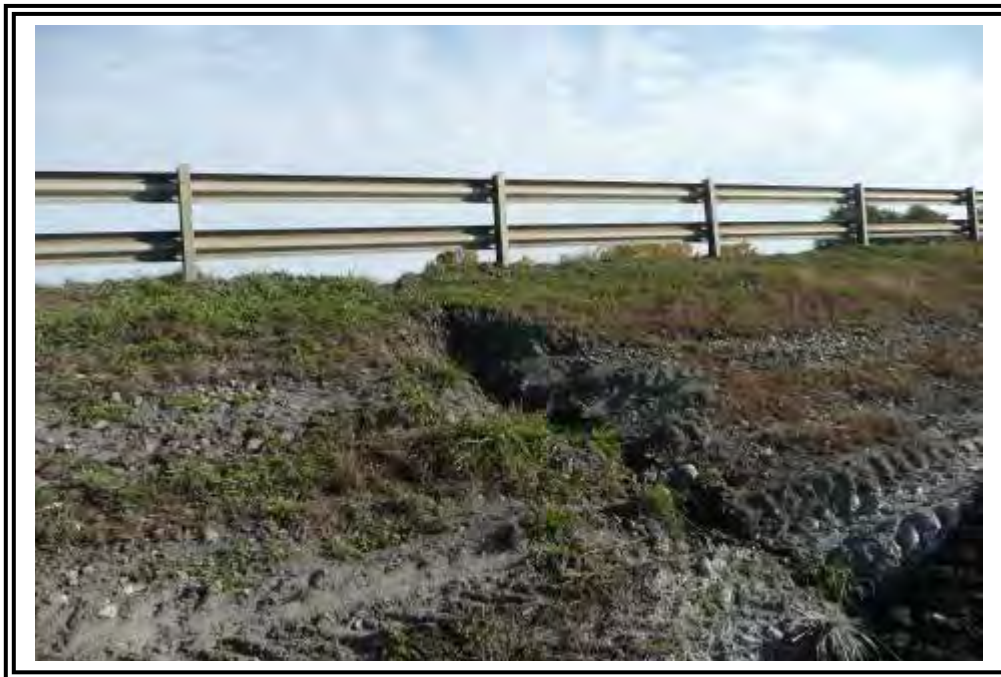
4

Large erosion rill and rutting on the upstream slope of the North Haul Road Dike.

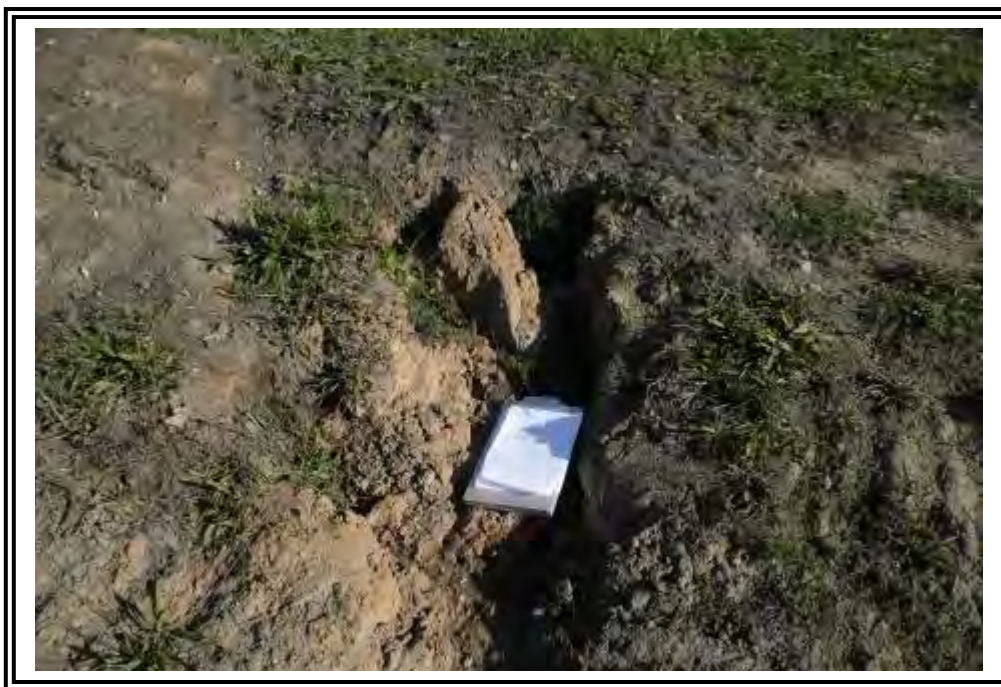
5

A close up of a large erosion rill and loss of vegetation on the upstream slope of the North Haul Road Dike.

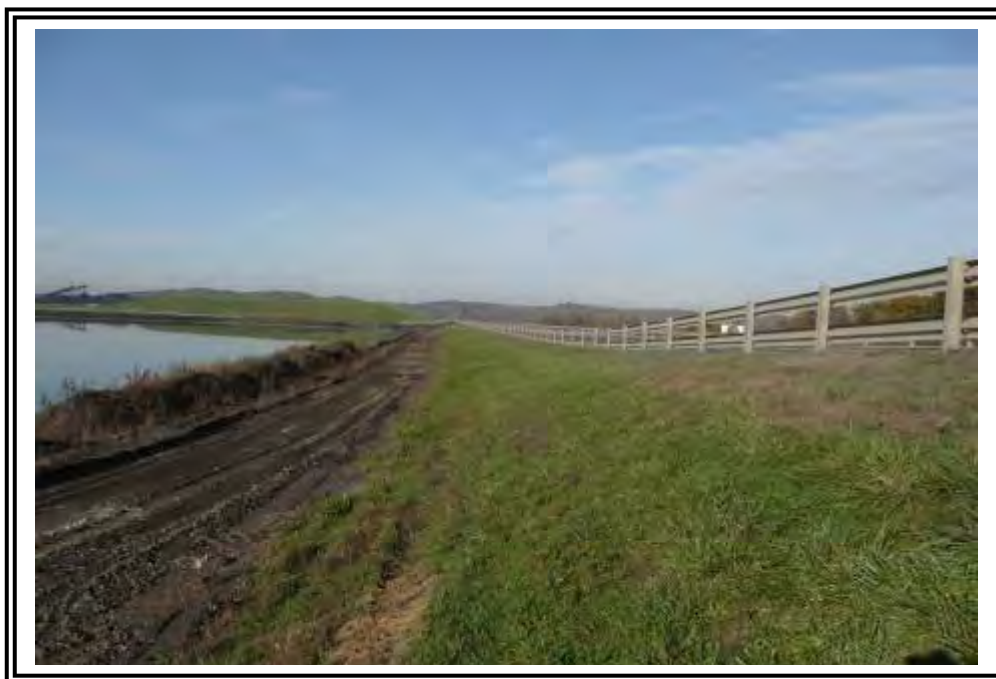
6

Looking west along the upstream slope of the North Haul Road Dike.

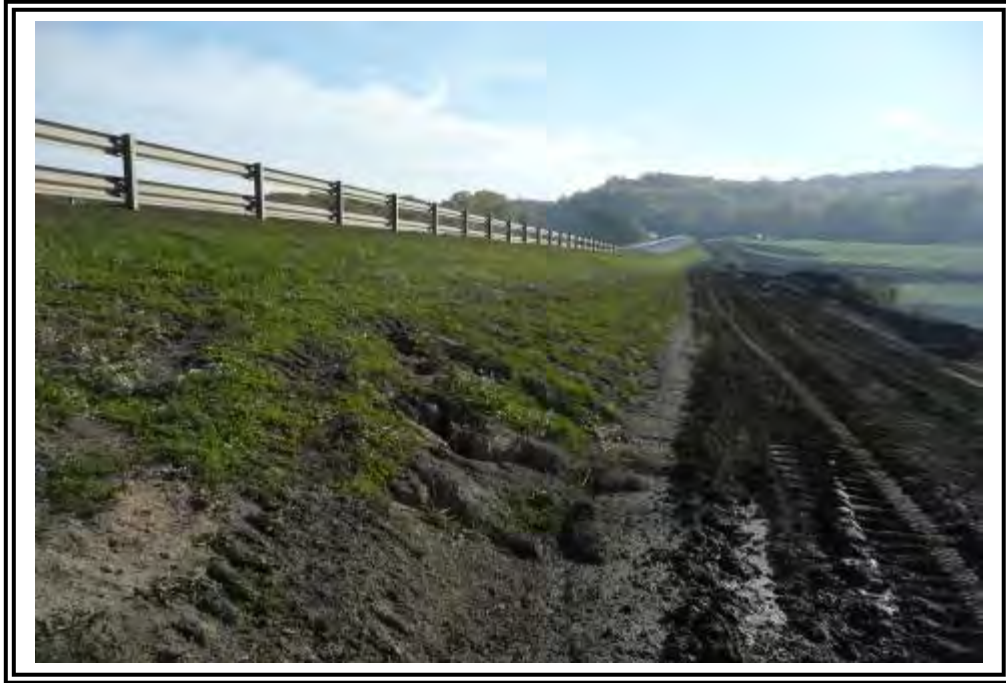
7

Looking east along upstream side of the North Haul Road Dike.

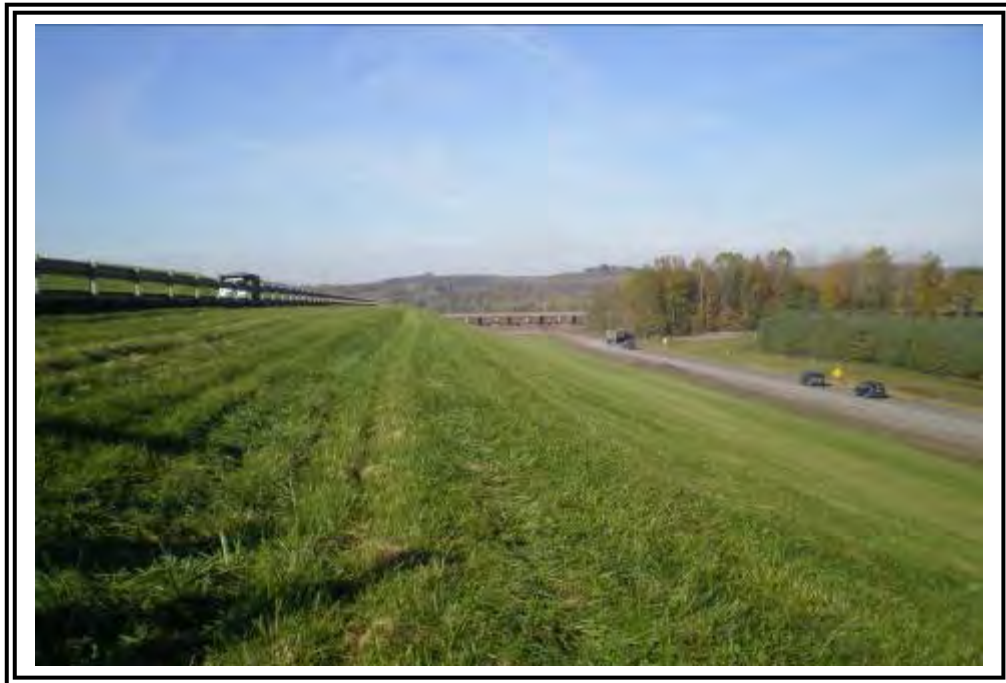
8

Looking west along downstream slope of the North Haul Road Dike. Country Route 273 shown on the right.

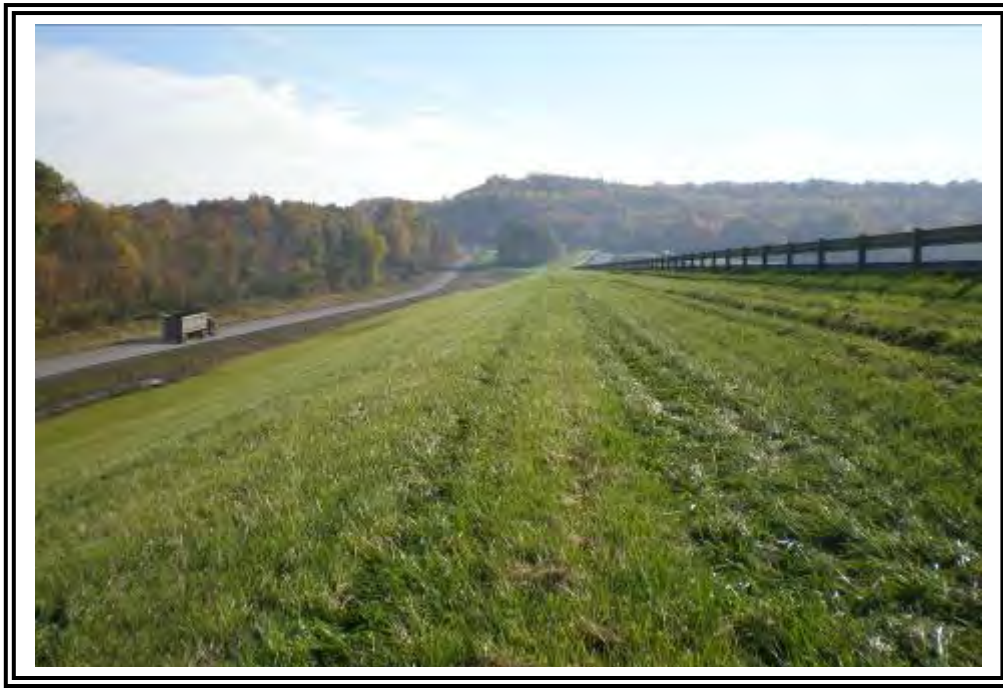
9

Looking east along downstream slope of the North Haul Road Dike.

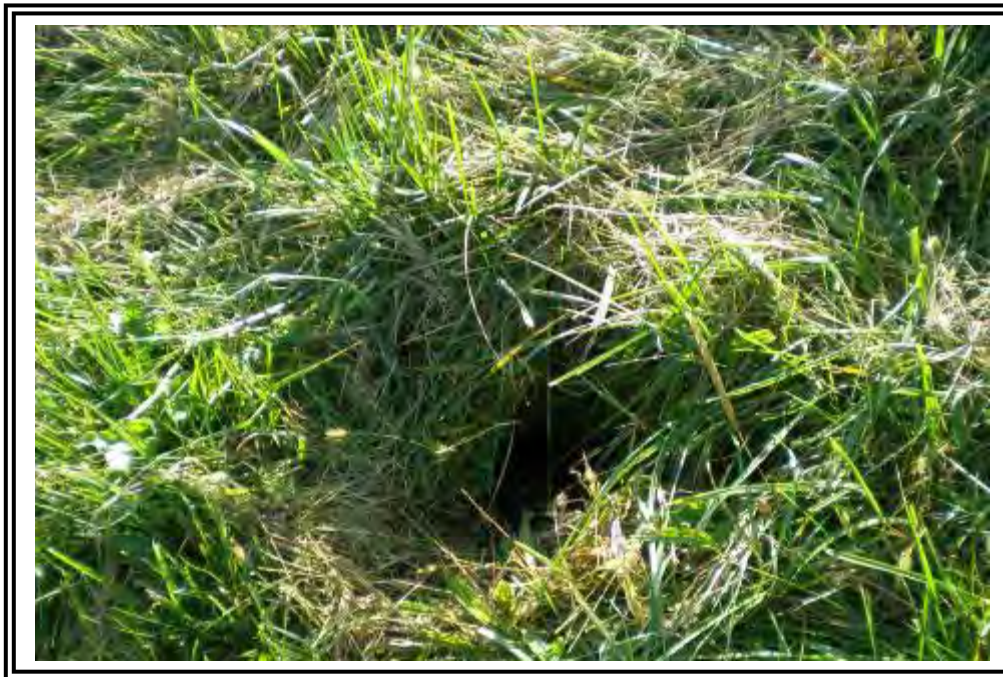
10

Close up of an isolated rodent hole in the downstream slope of the North Haul Road Dike.

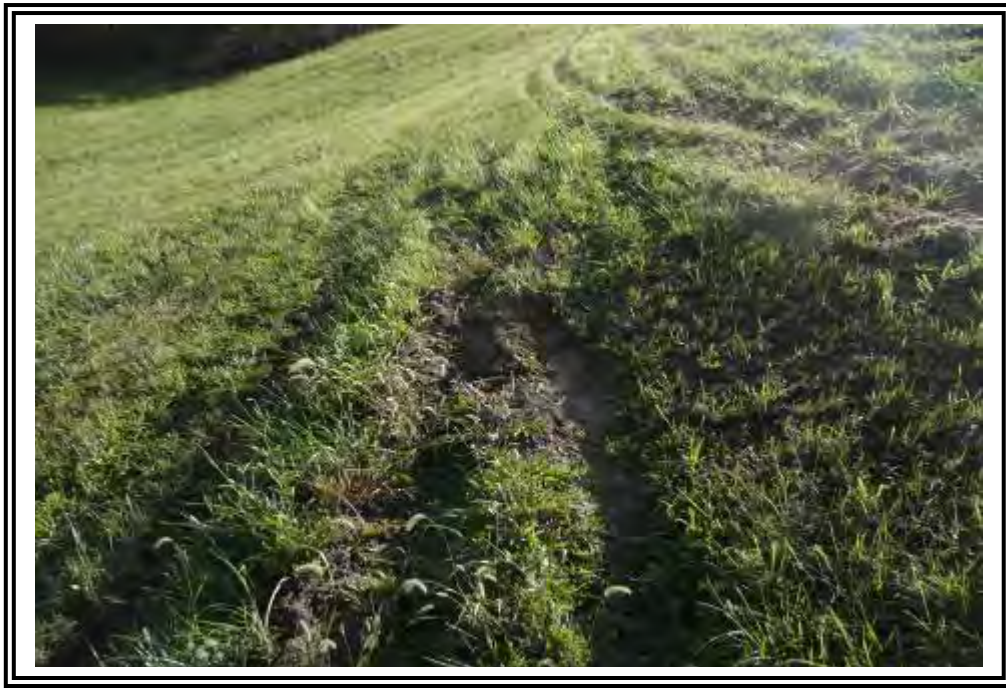
11

Close up of rutting and loss of vegetation on the downstream slope of the North Haul Road Dike.

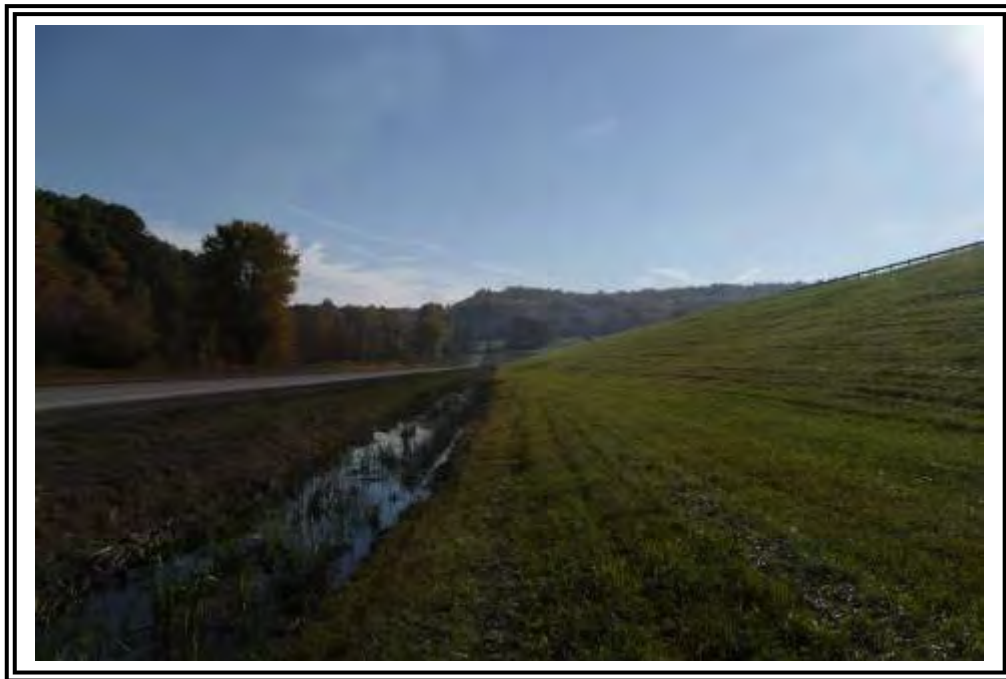
12

Toe of the North Haul Road Dike, looking east.
Standing water in the road ditch along toe can be seen in left of photo.

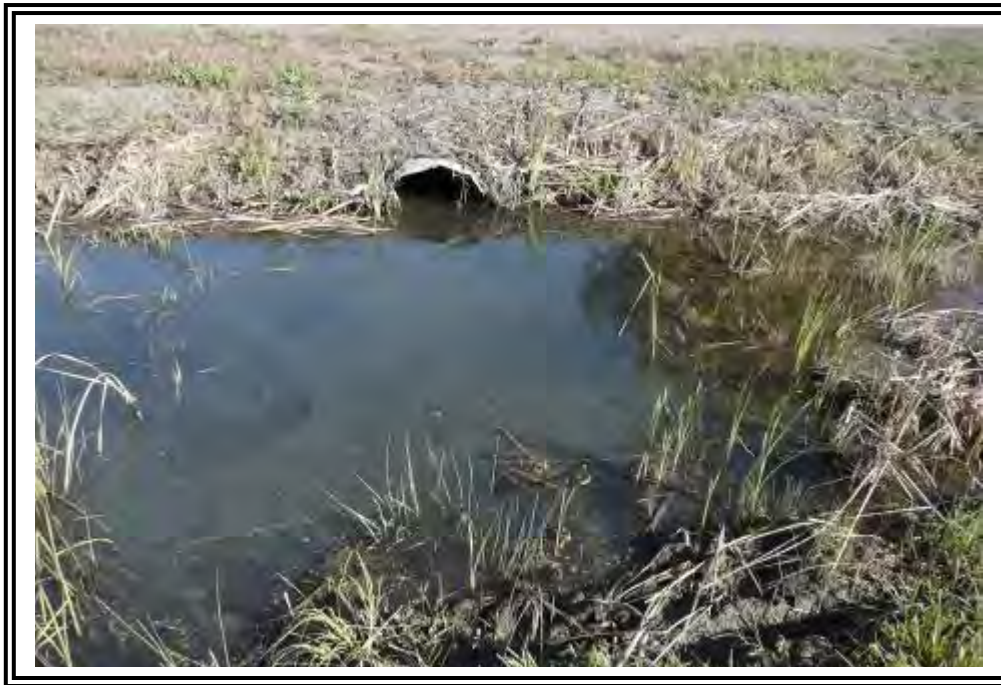
13

Close up of the half submerged drainage pipe under the county road.

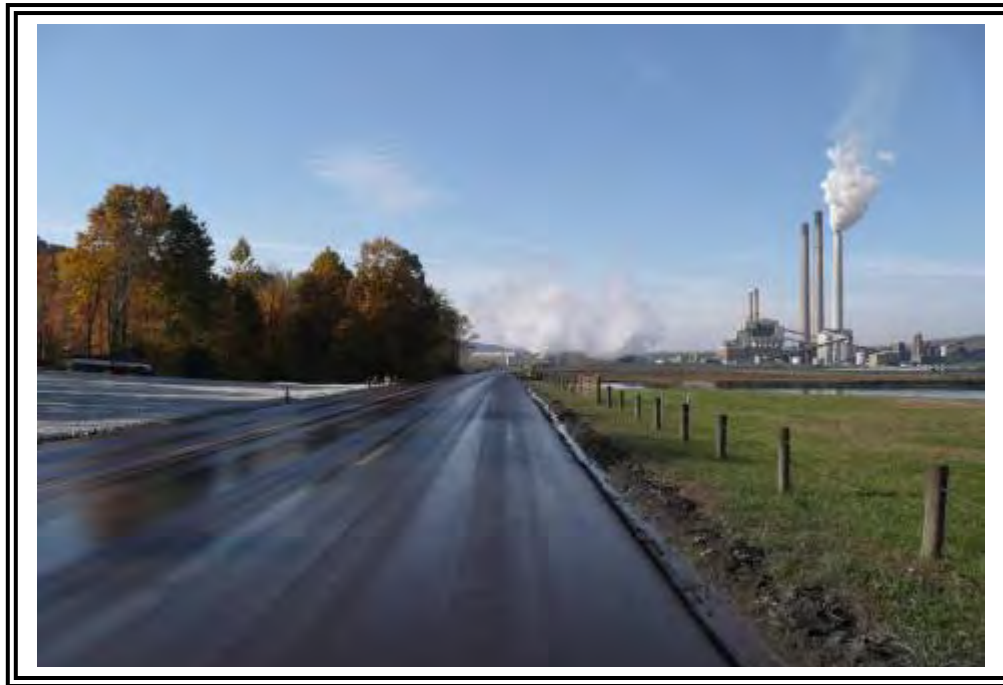
In general, the alignment of the Coal Haul Road and Secondary Dike crests do not show signs of change in horizontal alignment. No evidence of prior releases, failures or patchwork was observed at the time of the site visit. Photo Nos. 15 and 16 show the general condition of the dike crest.

Looking southwest along the Coal Haul Road. Road is wet to keep the dust from trucks down.

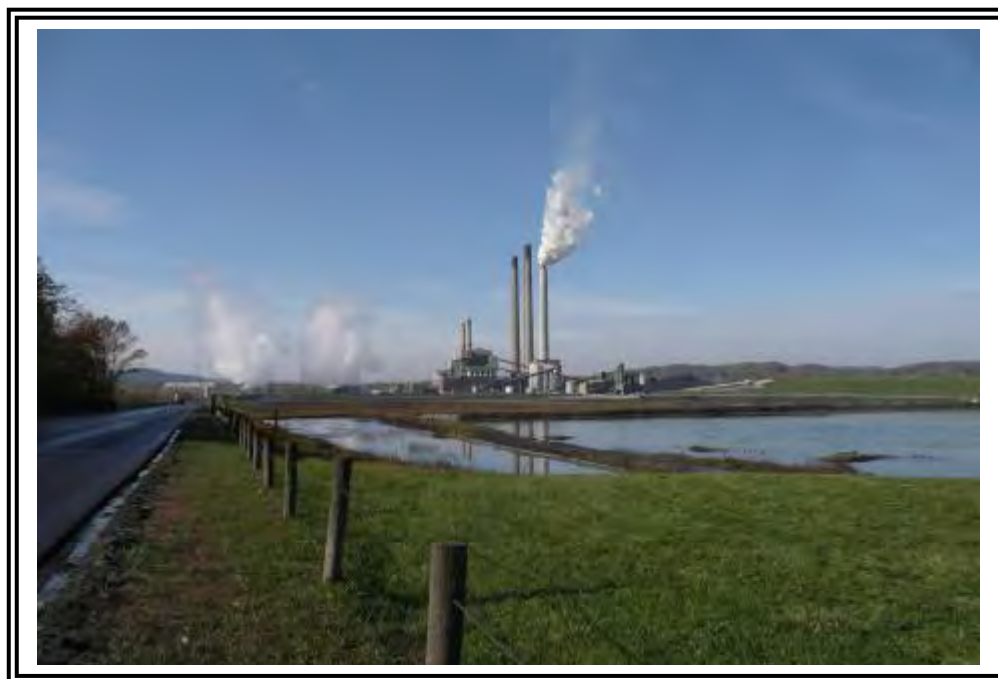
16

Looking southwest along the northeast crest and upstream slope of the Coal Haul Road Dike.

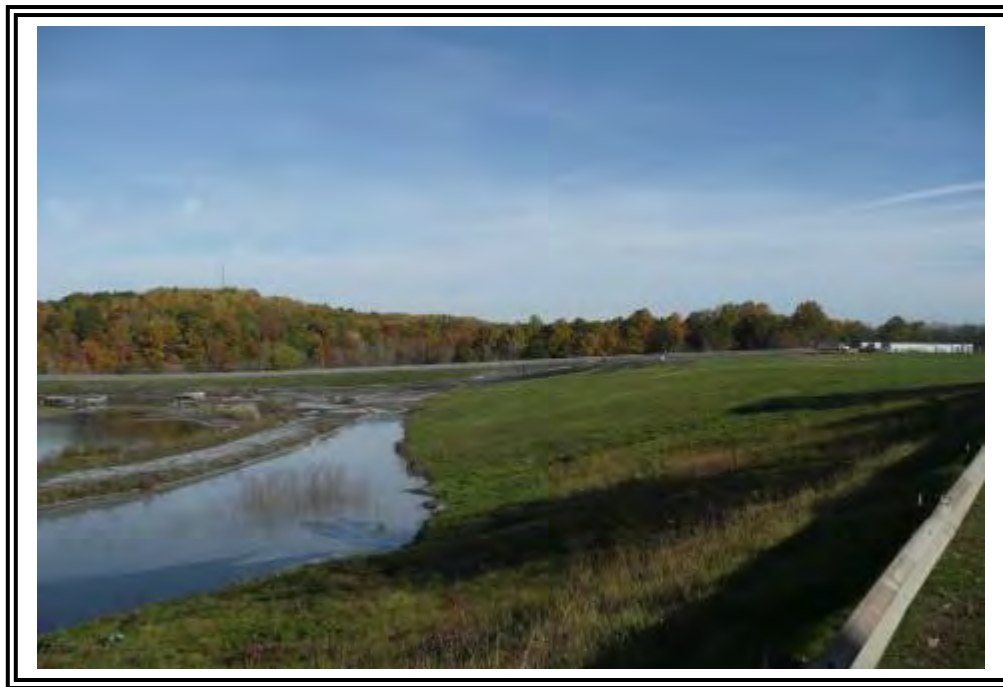
17

Looking northeast along upstream slope of the Coal Haul Road Dike.

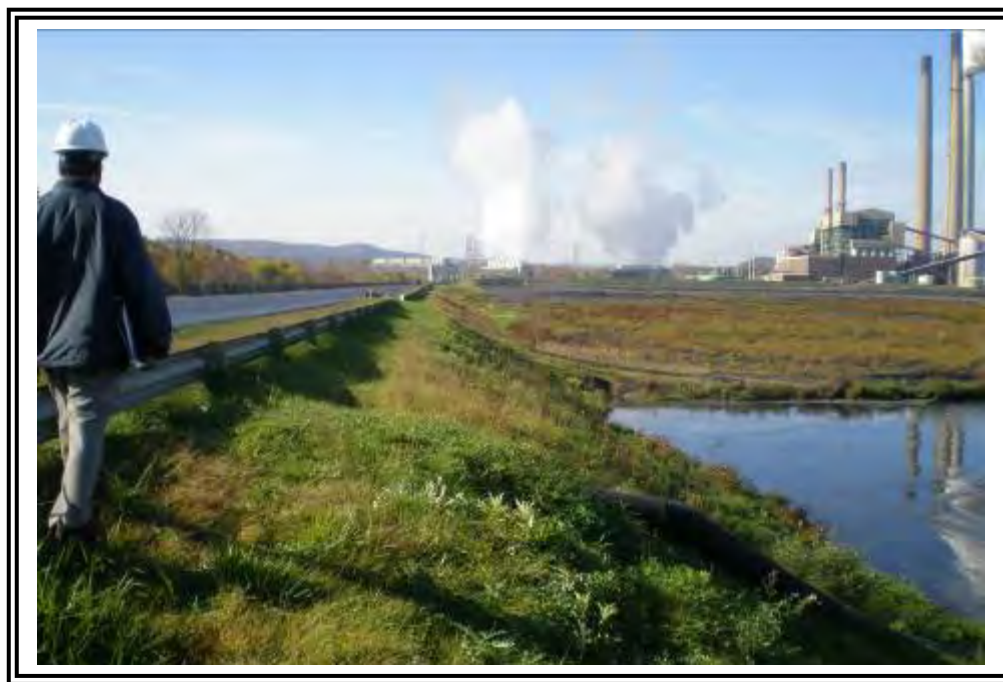
18

Looking southwest at upstream slope the Coal Haul Road Dike toward the south corner of the Fly Ash Pond.

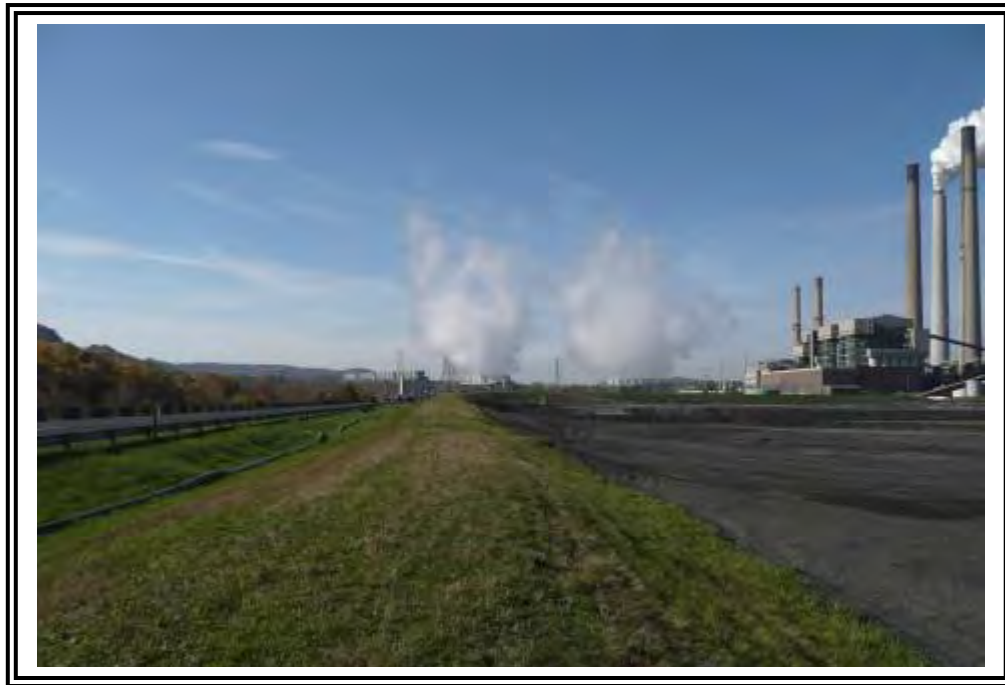
19

Looking southwest along the crest of the Coal Haul Road Dike where its alignment leaves the haul road and runs parallel to it.

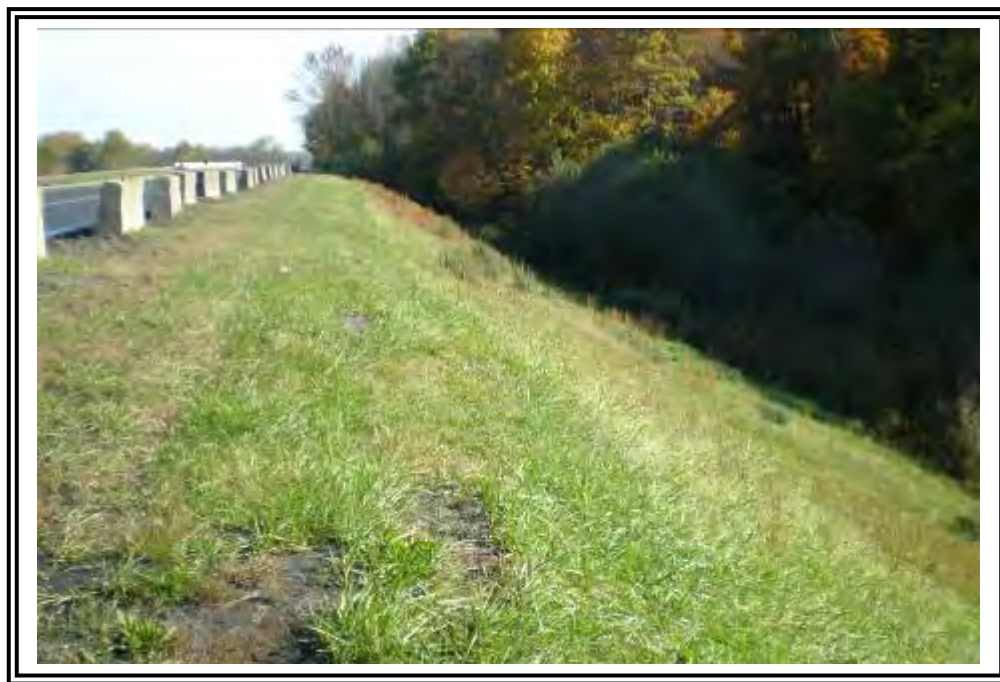
20

Looking northeast along downstream slope of the Coal Haul Road Dike. Small trees and moderate vegetation lower on the slope can be seen in the shade in the right of the photo.

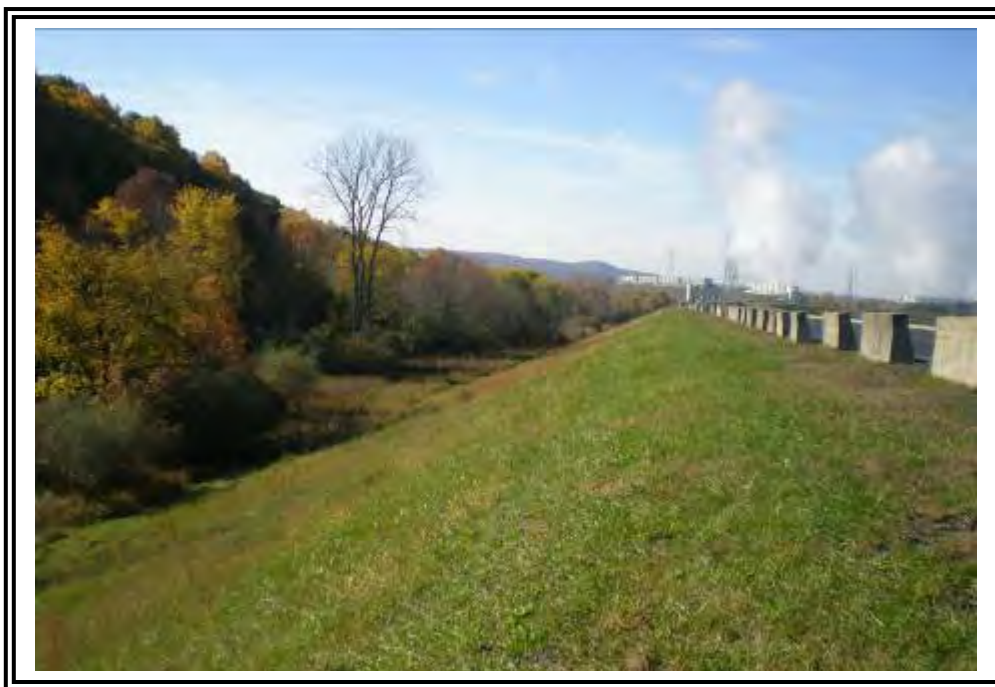
21

Looking southwest along downstream slope of the Coal Haul Road Dike.

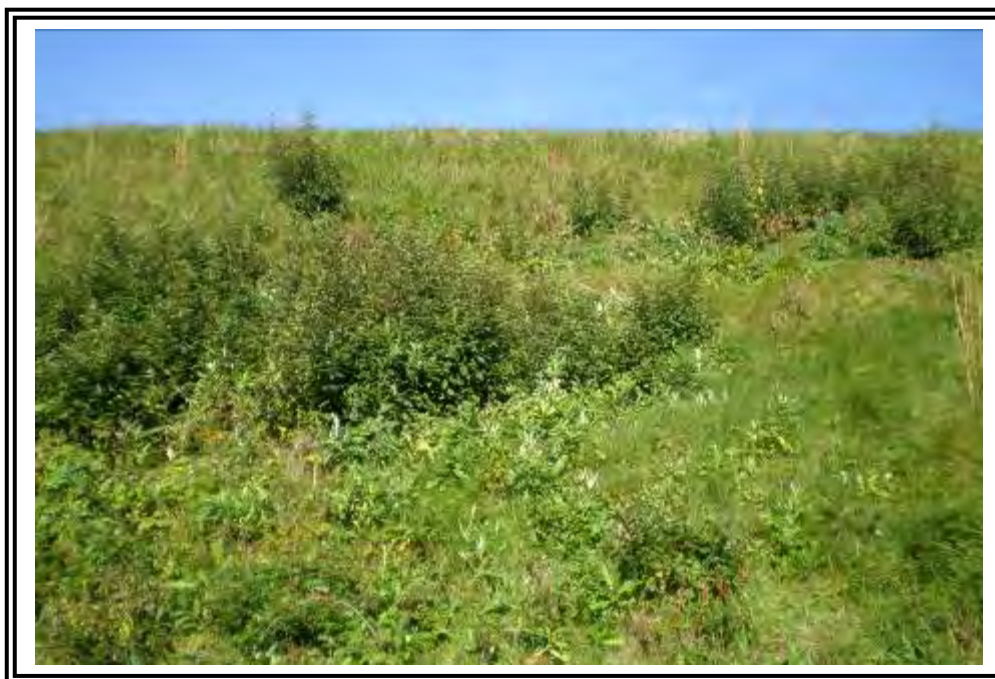
22

Close up of the moderate vegetation on the downstream slope of the Coal Haul Road Dike.

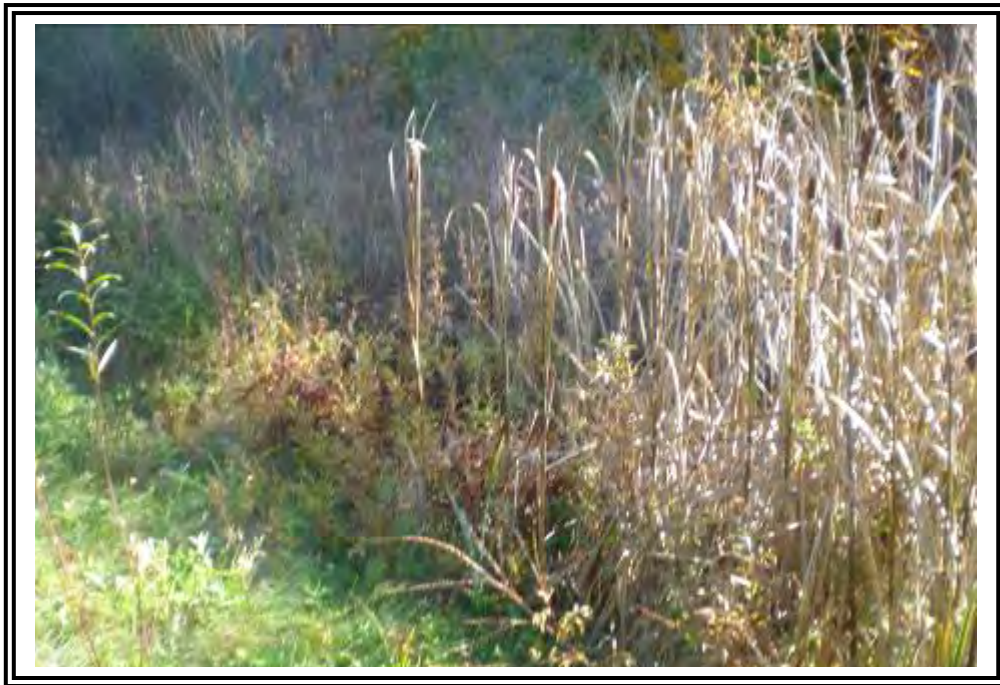
23

Heavy vegetation near the toe of the Coal Haul Road Dike.

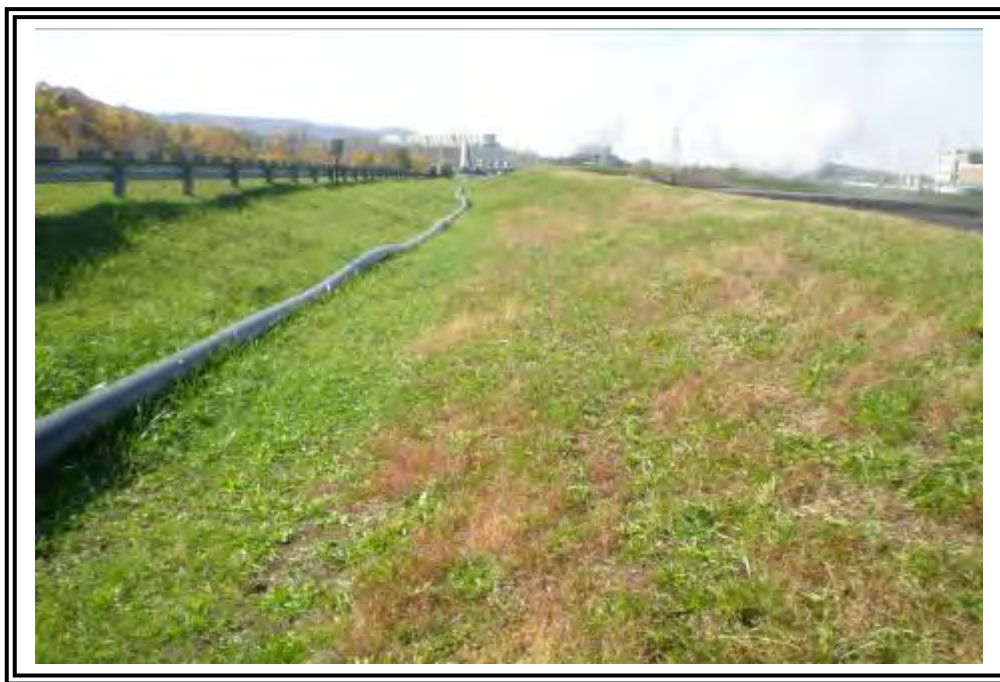
Photos 24 and 28 shows the downstream slope of the Secondary Dike adjacent to the Clearwater Pond was uniformly graded with appropriate grass cover. Photo 27 shows the upstream slope of the Secondary Dike adjacent to the Clearwater Pond. Isolated rutting and loss of the grass cover from mowing operations, as seen in Photo 29, were observed during the inspection.

Looking southwest along downstream slope of the dike where the dike runs parallel to the west of the coal haul road.

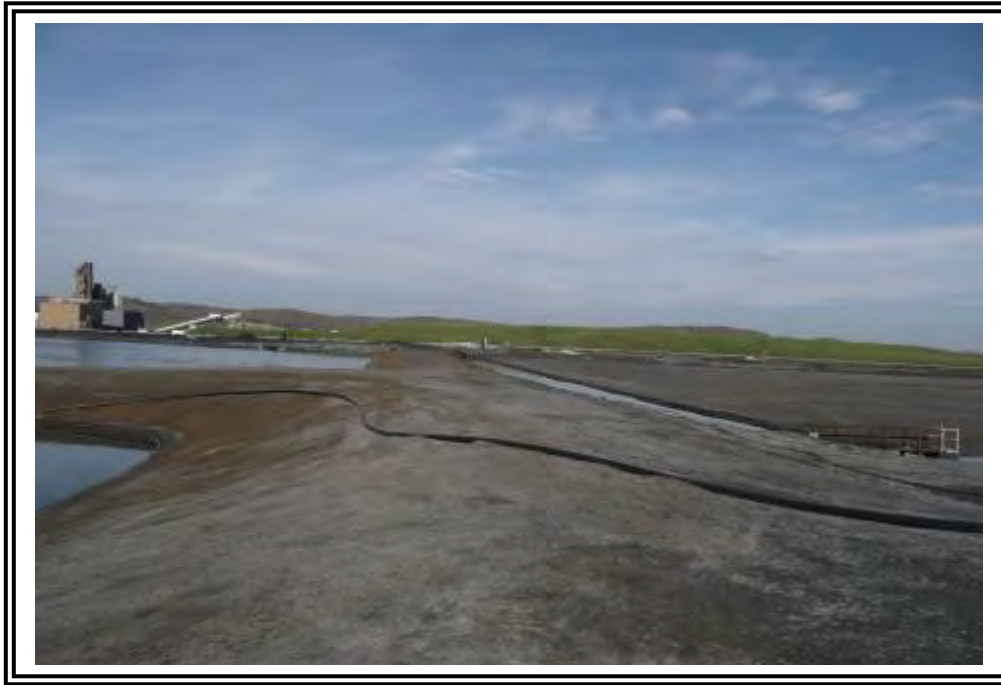
The crest of the splitter dikes appeared reasonably uniform as shown in Photos 25 and 32. Most of these splitter dikes were generally void of vegetation where activity in the pond area is ongoing or has been fairly recent. Less active areas, as noted in Photo 61, begin to support moderate weedy and small brushy vegetation. An approximately 1 to 3 foot difference in the water level on opposite sides of the splitter dikes was observed. No evidence of prior releases, failures or patchwork was observed at the time of the site visit

Looking northwest along crest of the splitter dike between the Fly Ash Pond to the north and the Bottom Ash Pond and Clearwater Pond to the south. The Fly Ash Pond outfall structure is on the right side of photo.

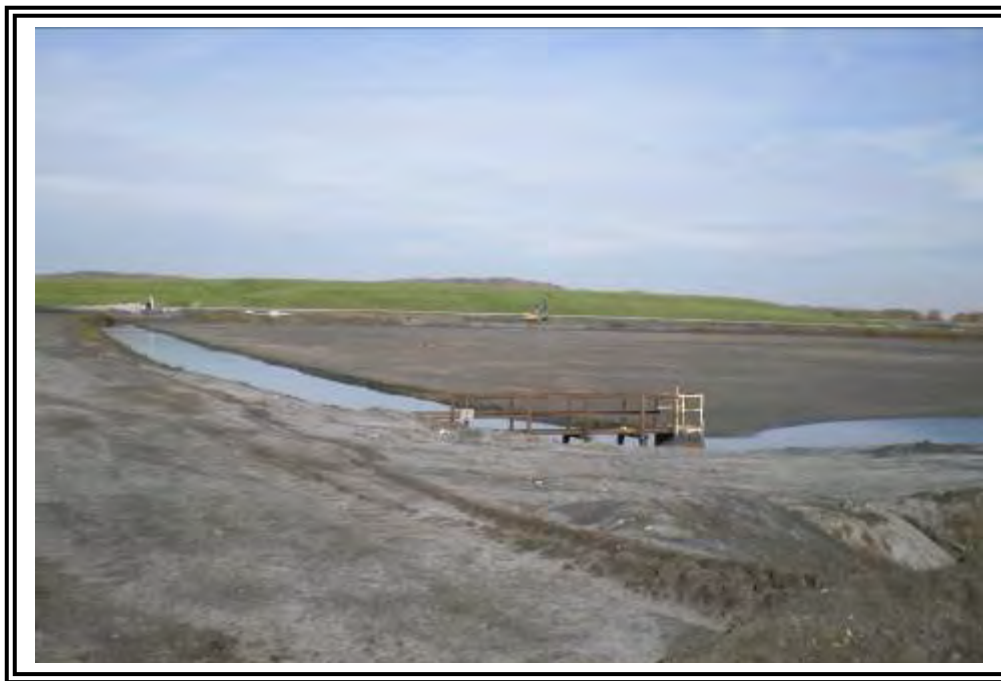
26

Close up of the Fly Ash Pond outfall structure.

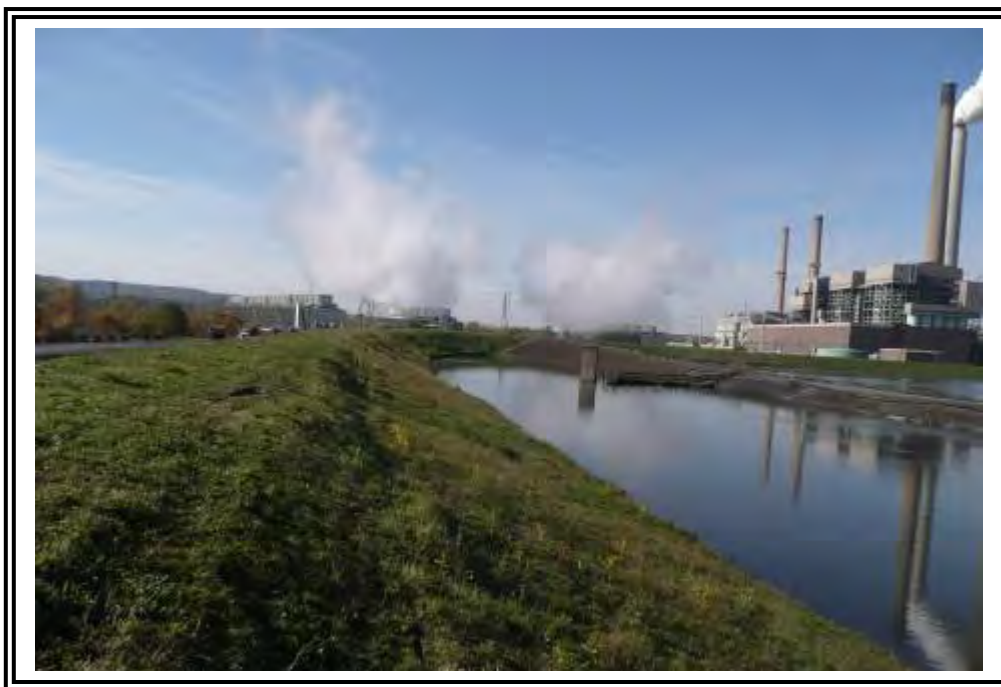
27

Looking southwest along upstream slope of the Coal Haul Road Dike adjacent to the Clearwater pond.

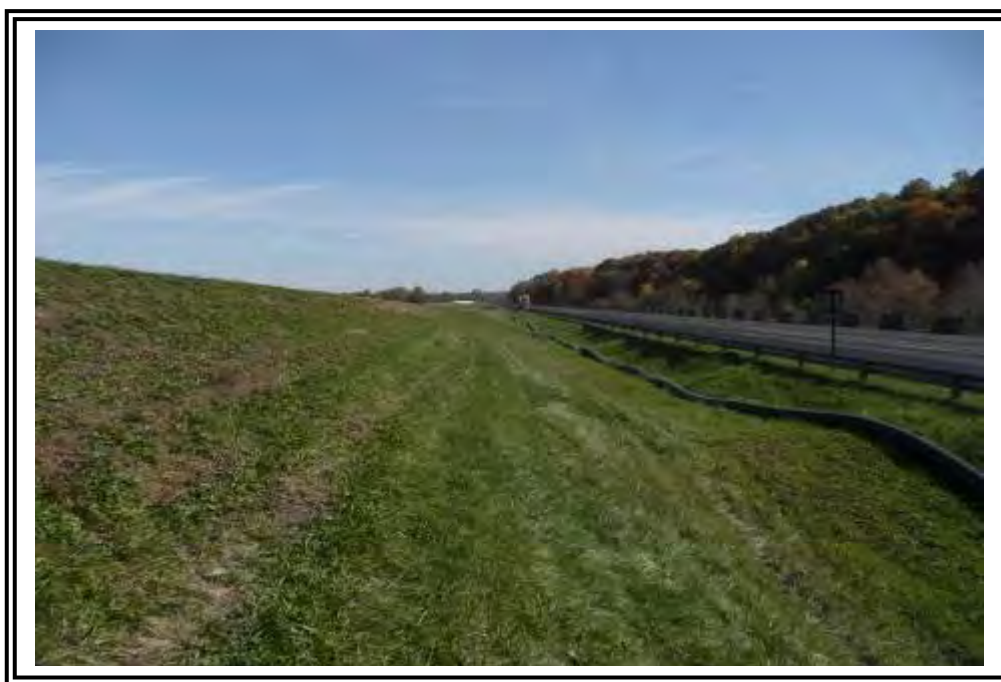
28

Looking northeast along the downstream slope of the Coal Haul Road Dike adjacent to the Clearwater Pond.

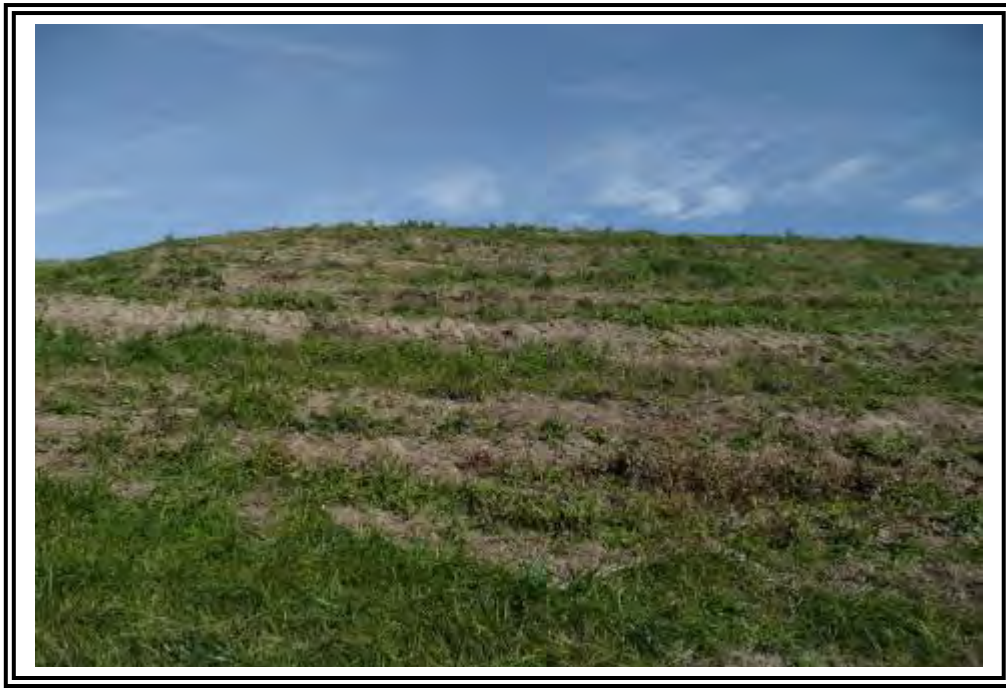
29

Close up of rutting and loss of grass vegetation on downstream slope due to mowing operations.

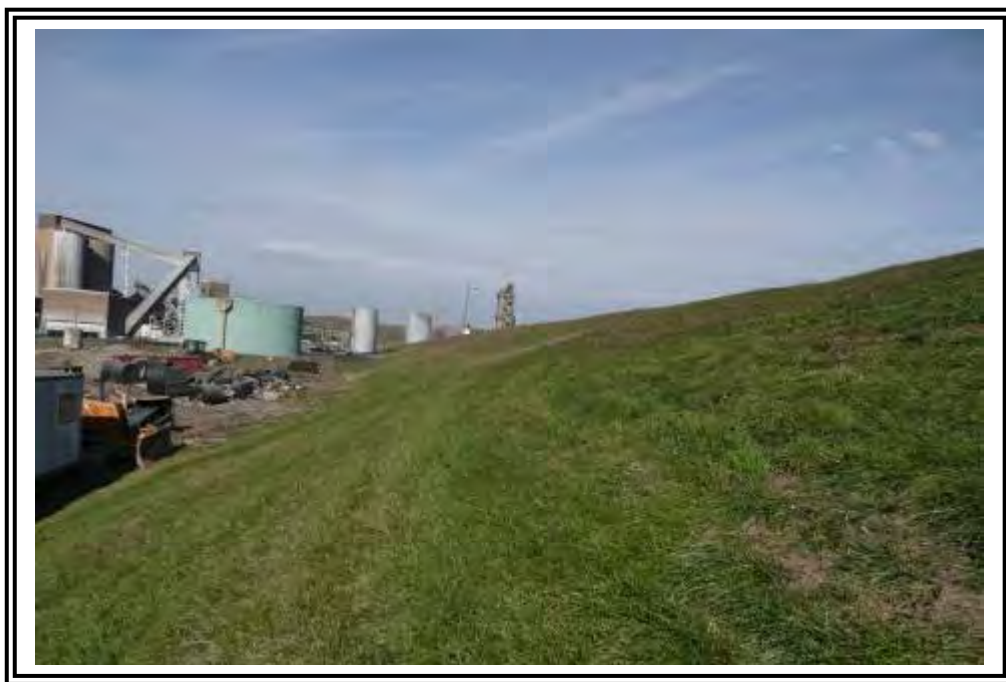
30

The upstream slope was covered with appropriate grass vegetation and generally appeared to be in a stable condition. Isolated minor features such as a collapsed, vegetated, likely abandoned rodent burrow, slope undulations likely due to grading activities, and stressed grass cover were observed in this area as indicated in Photos 38 and 60. Slight beaching erosion, as noted in Photos 36 and 37, could be seen on the upstream slope at the water surface where the water level appears to fluctuate over time. The downstream slope was generally uniformly graded, and covered with appropriate grass vegetation as shown in Photo 30.

Looking northwest along downstream slope of the Southwest Dike.
The green metal cleaning tank can be seen on the left side of the background in the photo.

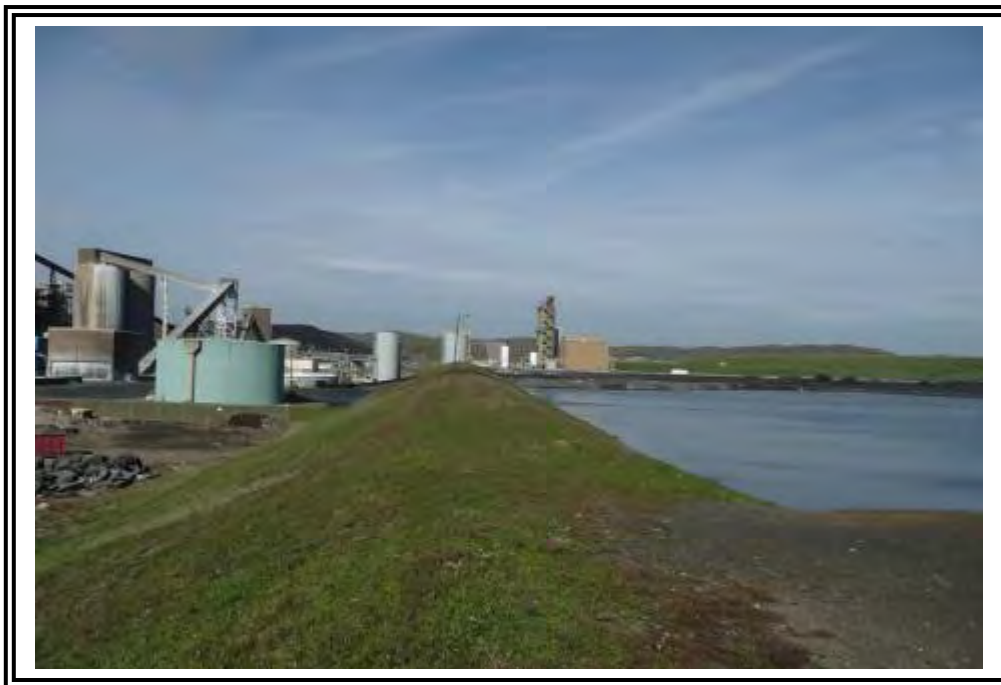
change in its horizontal alignment. No evidence of prior releases, failures or patchwork was observed at the time of the site visit. Photo 31 shows the dike crest alignment.

Looking northwest along crest of the Southwest Dike.

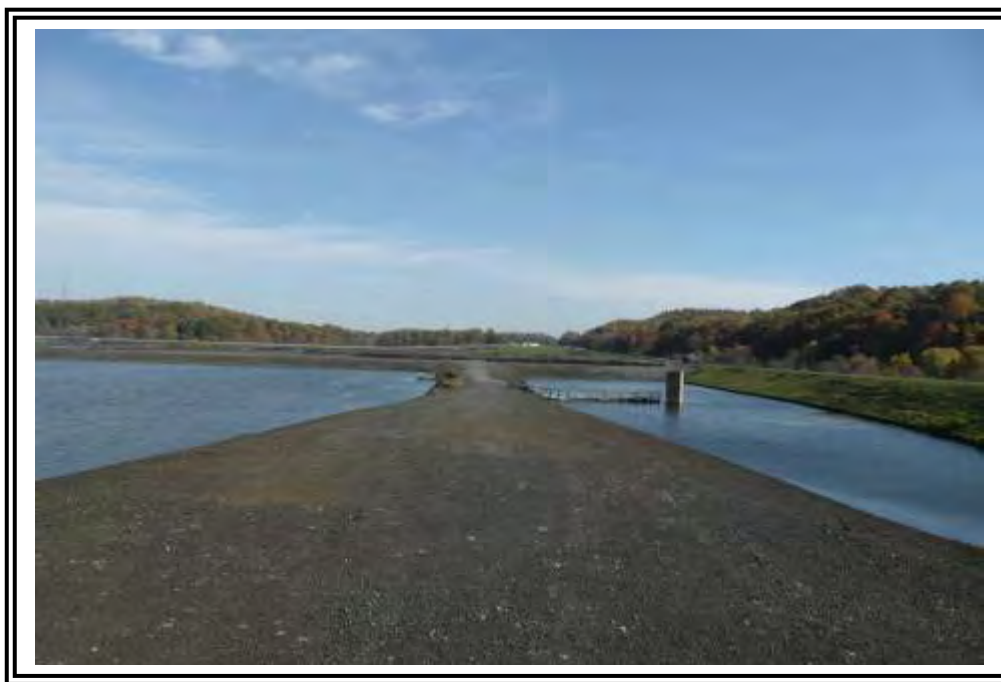
32

Looking northeast along crest of the splitter dike between the Bottom Ash Pond (left) and the Clearwater Pond (right).
